Building Inspection Report

Type of Report: Pre-Purchase Building Inspection

Type:	Domestic	Townhouse
Bedrooms:	2	
Bathrooms:	1	
Ensuites:	-	
Car Park:	Single	
Height:	Two Story	
Building:	Brick Veneer	
Piers:	-	
Floor:	Timber with concrete areas	
Roof:	Metal	
Age:	-

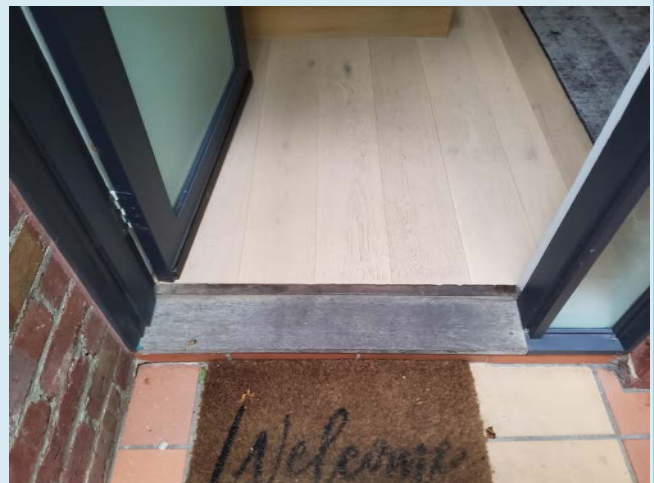
Hallways and general living spaces	
General Advice/Minor Defect	Doors
Comments	
<p>Recommend fitting a door stop to prevent wall damage from the door handle. Recommend painting or staining the door tread to protect from deterioration.</p>

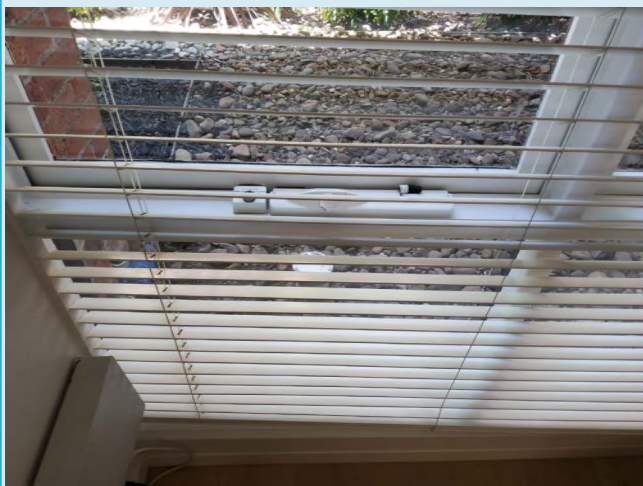
Windows

A front window winder handle was broken. Recommend replacing the winder block/mechanism. Contact a handyman service.

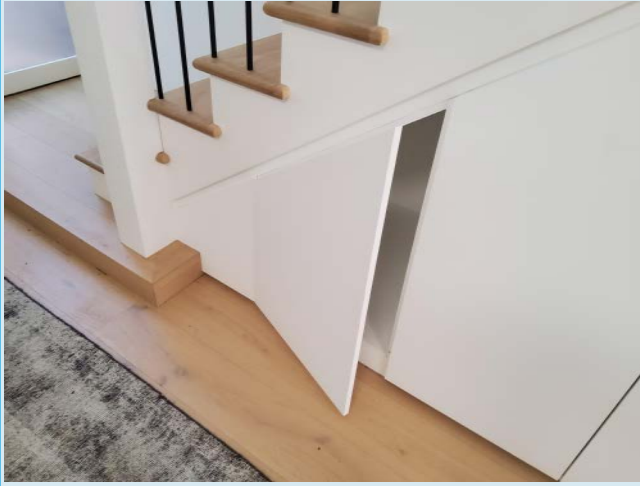
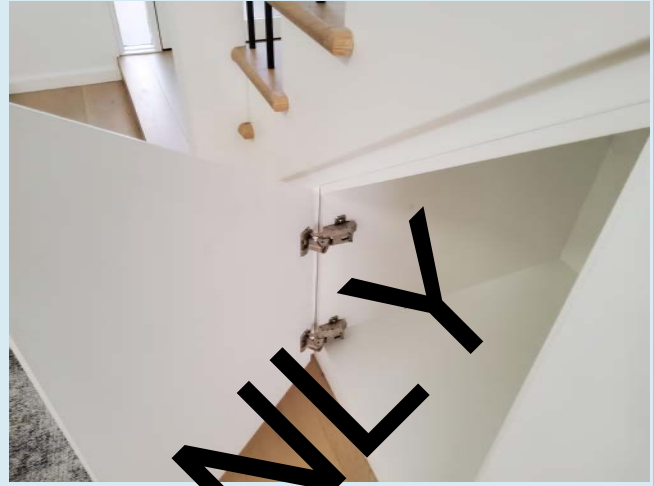
Kitchen	
General Advice/Minor Defect	Cabinets / Drawers
Comments	
Adjust cabinet door hinge so a door below the steps closes properly.

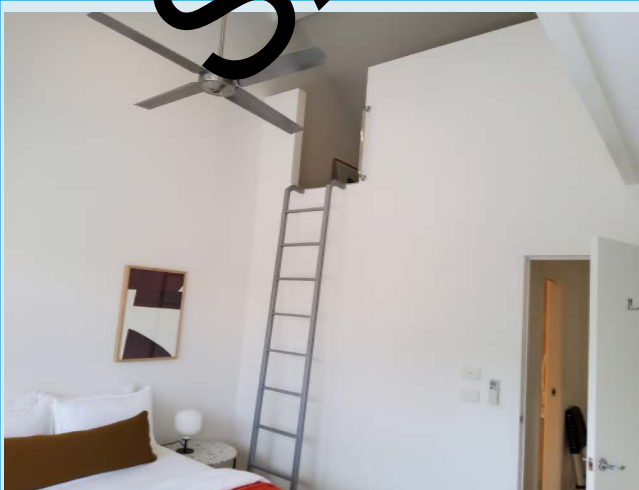
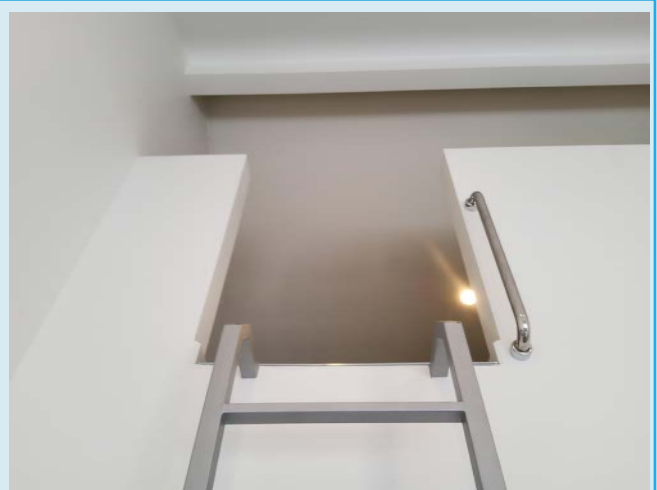
Bedroom 1	
General Advice/Minor Defect	Walls
Comments	
Recommend installing another handle at the left side of loft opening for safer access.

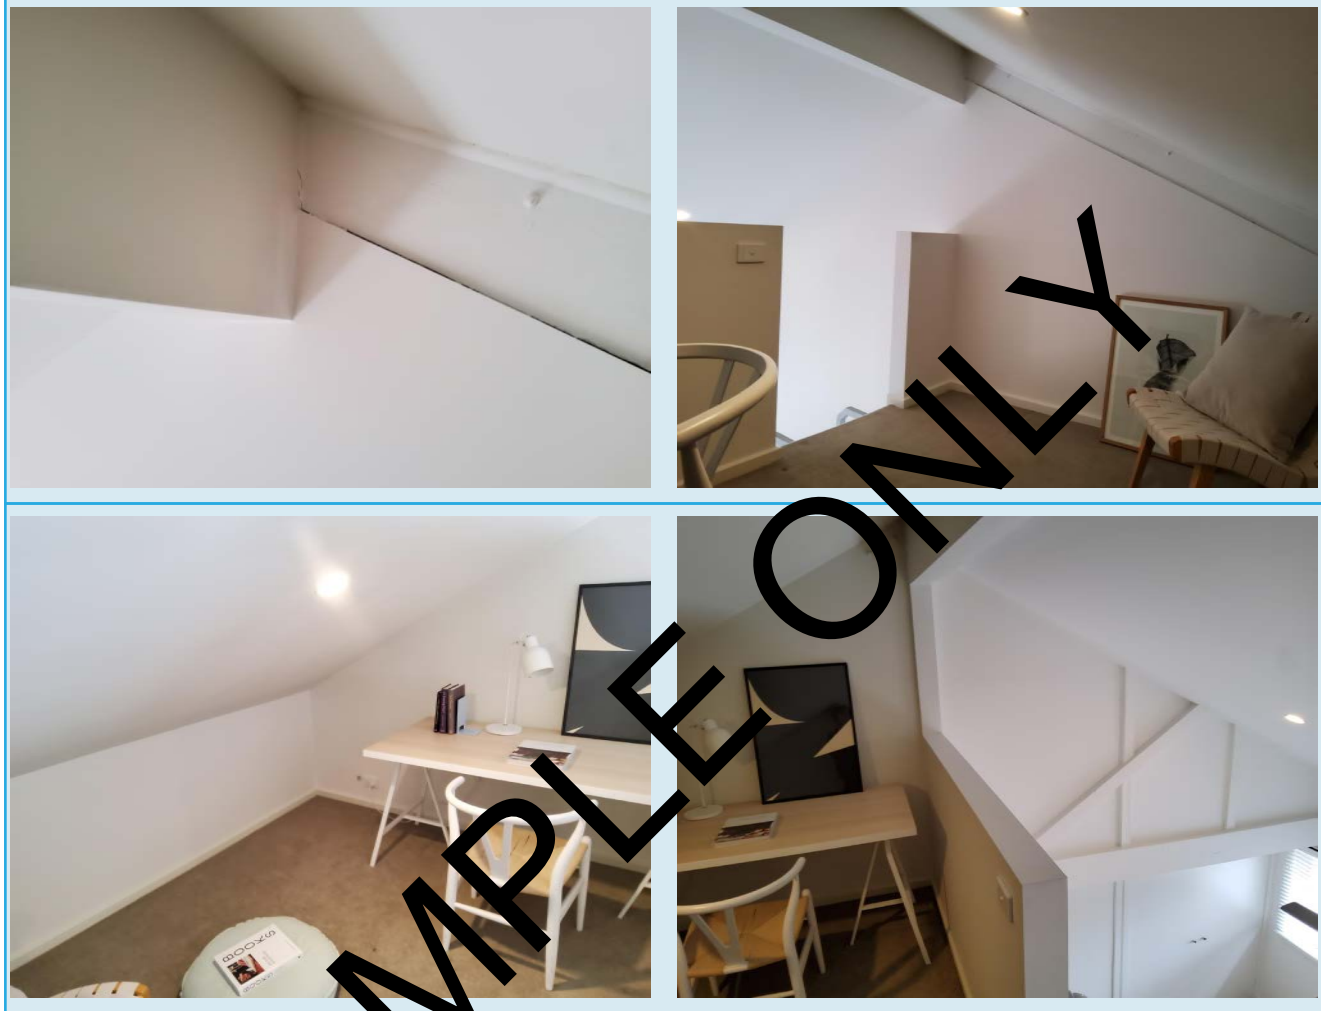
Bedroom 1	
General Advice/Minor Defect	Ceilings

Very slight crack noted to plaster alongside a roof beam. Loft area walls and walls throughout have been painted and appeared visually fine for the age and type of construction. There was no evidence of water damage or leaks.

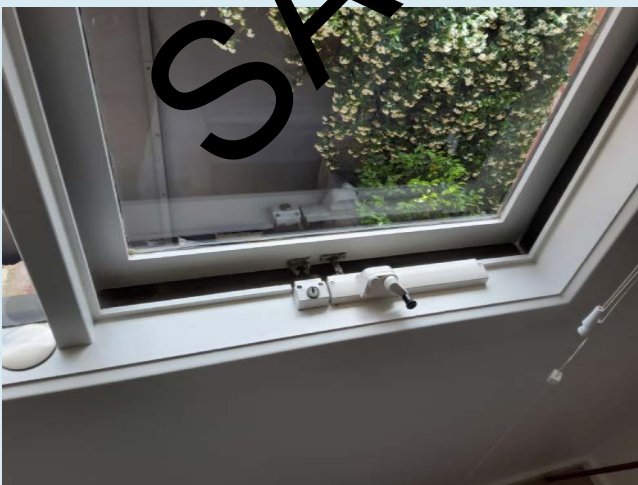
Window was jamming open. Recommend replacing the winder mechanism. Contact a handyman service.

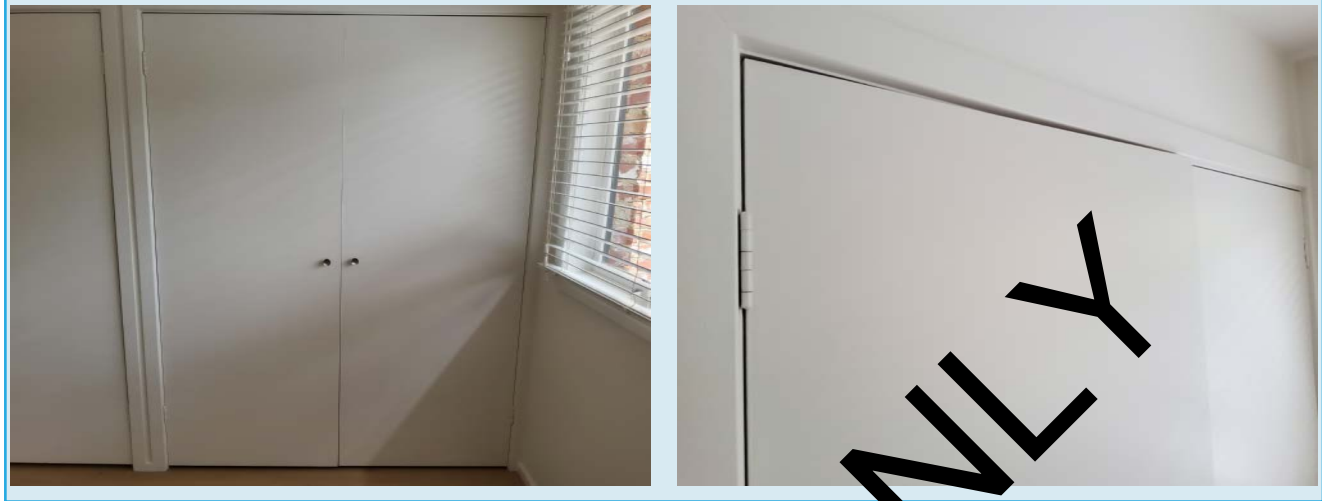
Bedroom 2	
General Advice/Minor Defect	Robes

Robe door not closing properly. Recommend adjusting the hinges.

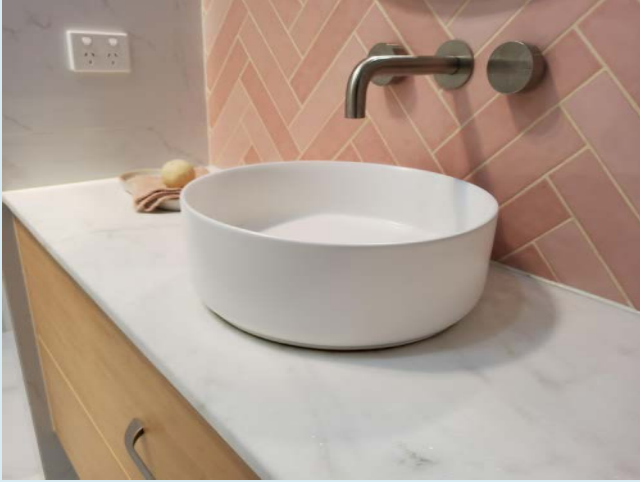
Bathroom 1	
General Advice/Minor Defect	Sealants
Comments	
Recommend installing sealant around the basin to prevent possible damp damage to cabinetry below.

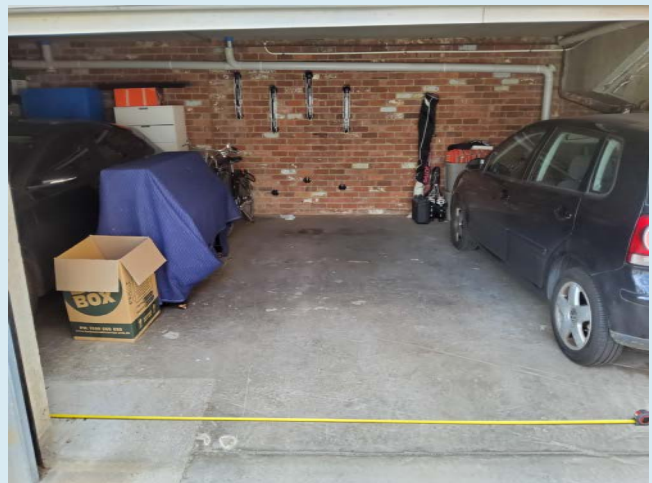
General advice - garage approximate length is 5.3m from the roller door to the back wall, and approximate width is 5.4m (double car space width from the right side wall to midline of the concrete pillar. Note it is single car space on the agents plan, so the approximate width would be 7m. Please refer to the contract or advice from your conveyancer for exact sizes).

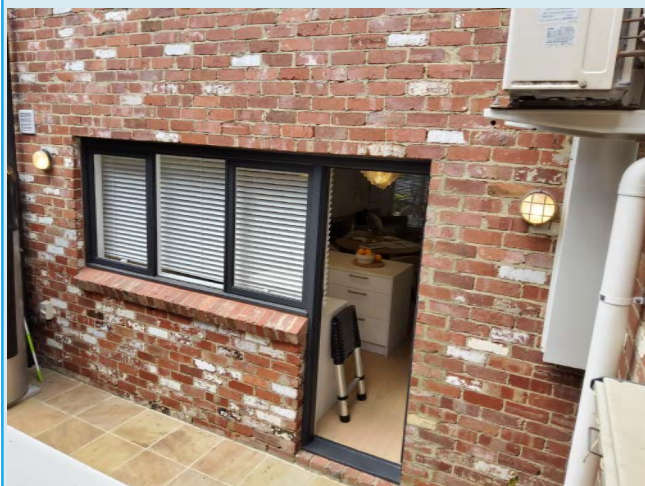
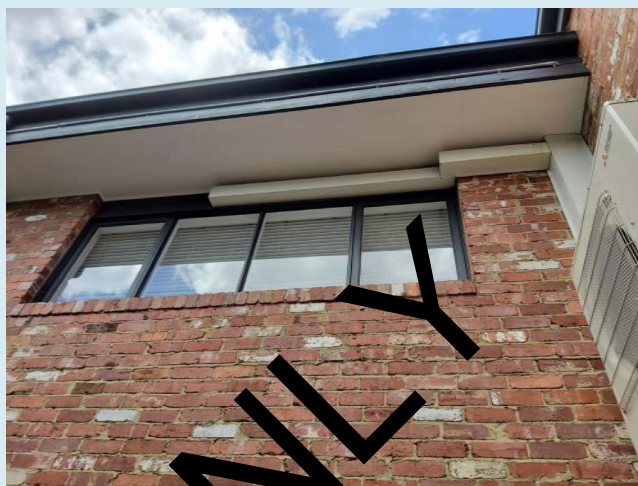
No evidence of major structural defects was found to walls of the townhouse.

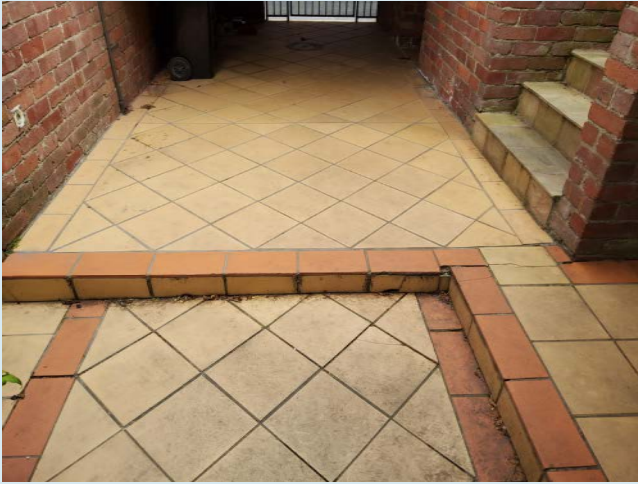
Slight cracks noted to common area pathway pavers.

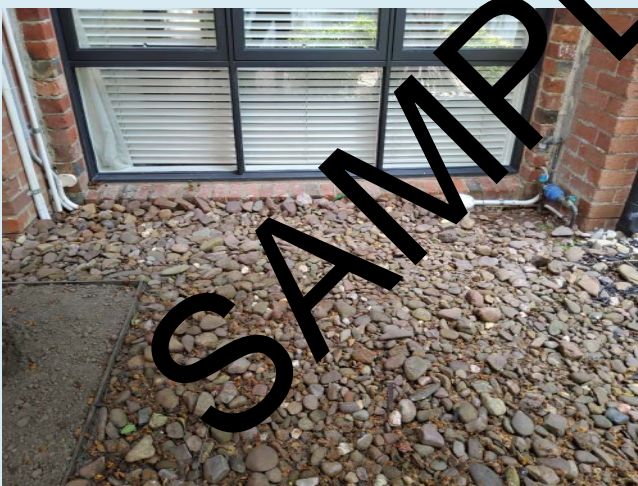
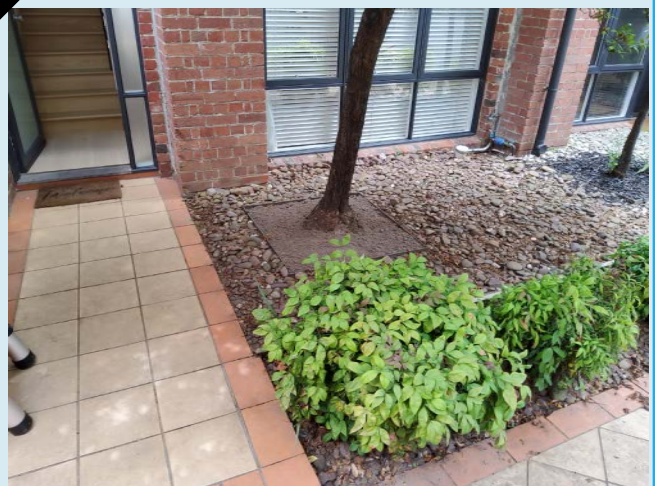
There is a drainage riser pipe in the front yard, but no drainage pit. Recommend a plumber be engaged to grade the ground surface to a drainage pit and the stormwater drainage system, to minimise the risk of possible movement of footings and consequent damage to walls over time from regular rainwater seepage around the footings.

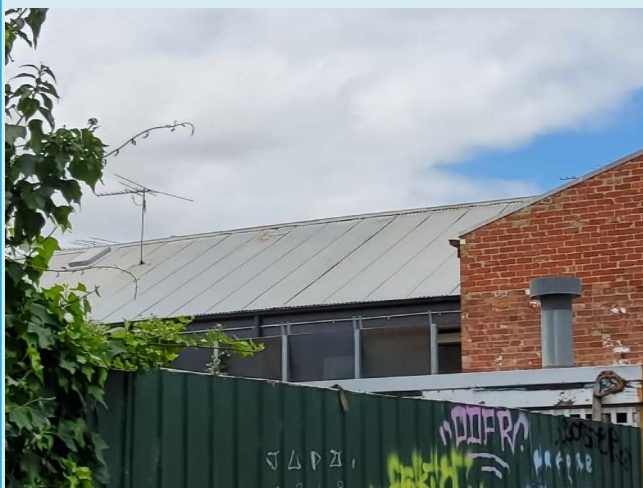
Upper level roof was unable to be safely accessed due to safe height restriction over 3.6m from the ground.
